Can Sea Level Rise and Accompanying Saltwater Intrusion Contribute to Catastrophic Building Failures?

Frederick Bloetscher¹, Ph.D., P.E.; Anthony Abbate¹, N.C.A.R.B., A.I.A.; and
Khaled Sobhan¹, Ph.D., E.I.

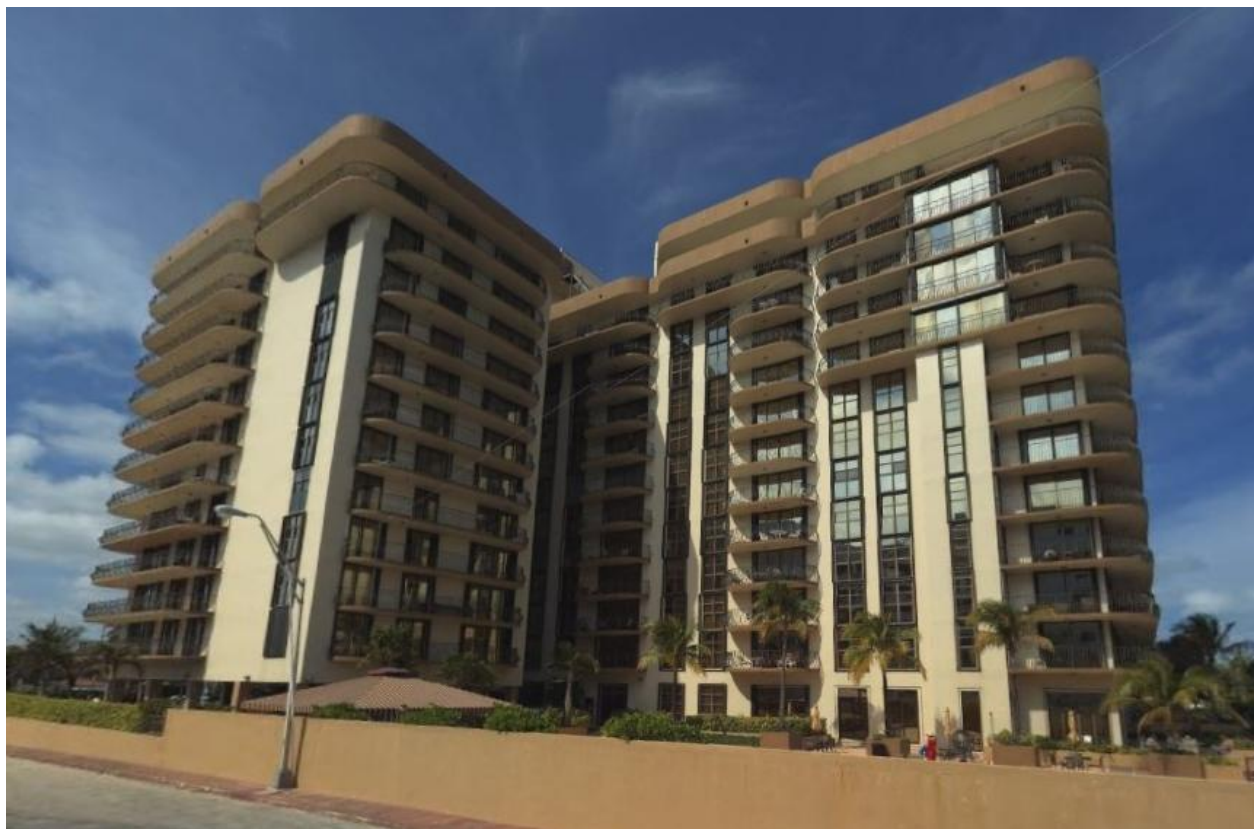
Figure 1. Champlain Towers prior to the collapse of the south tower. The portion of building that collapsed is on the right.

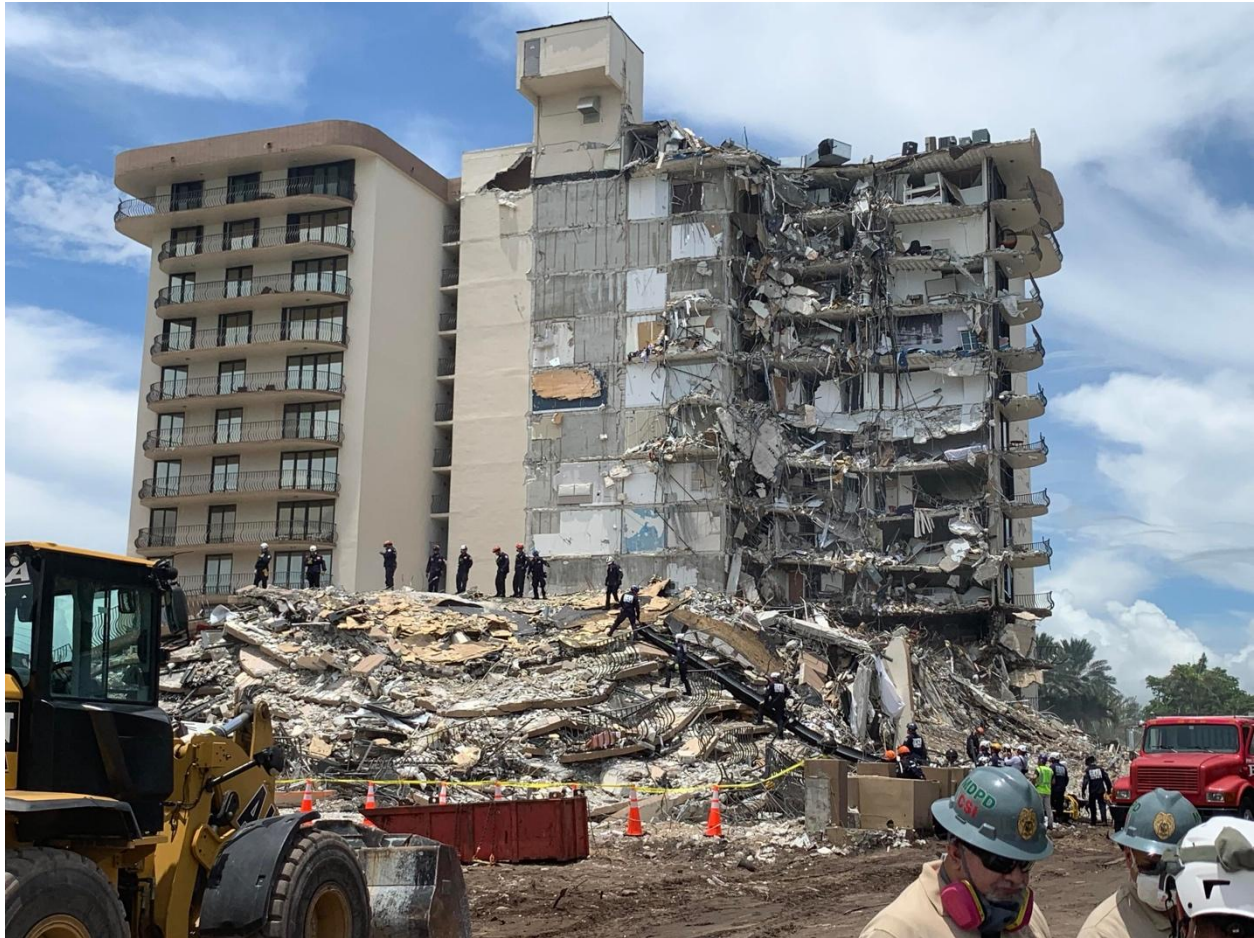
Figure 2. Search and rescue teams at the site of the collapse. Photo: National Institute of Standards and Technology (NIST, 2021).

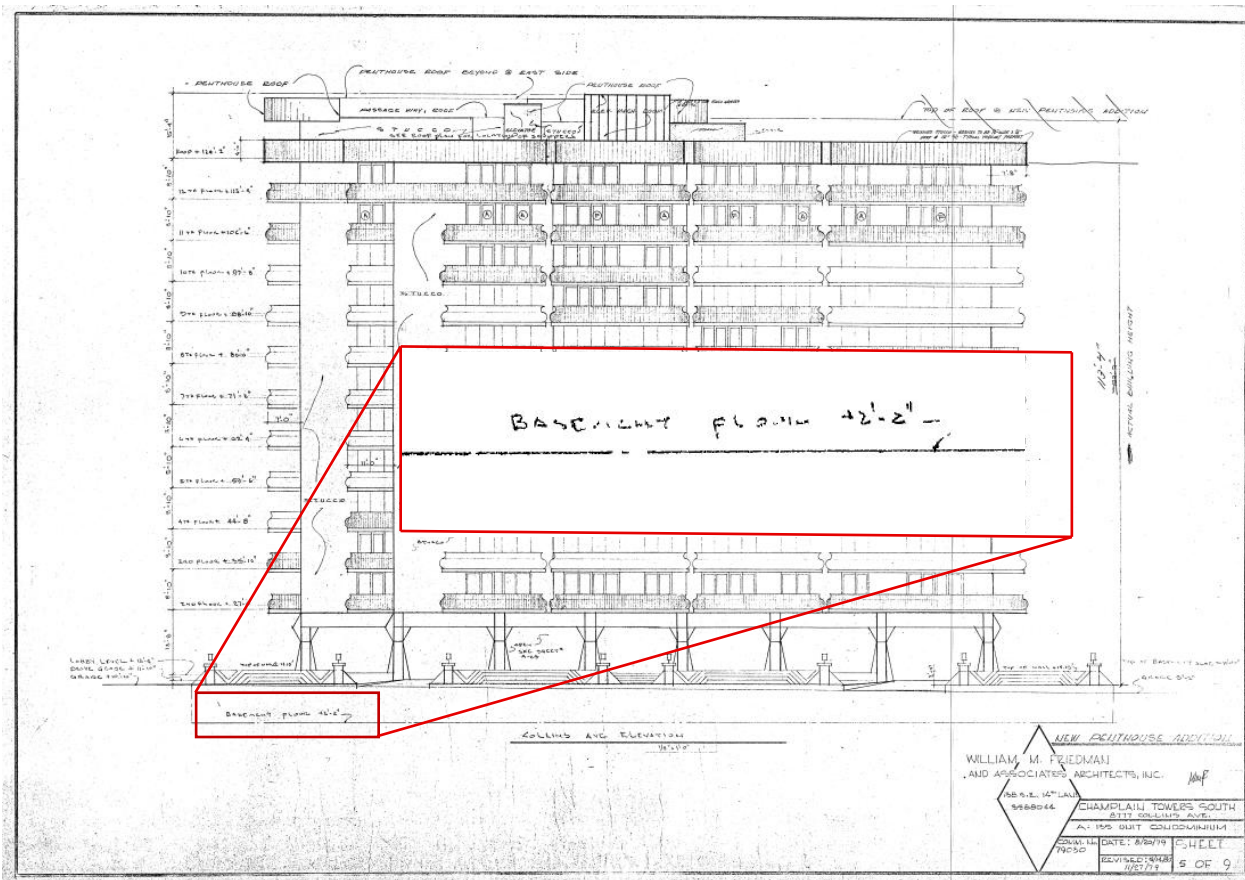
The architectural and engineering plans for Champlain Towers South were acquired and reviewed to determine the design elevations of the garage floor and foundation. Figure 7 shows the elevation of the Subject Building. The finished floor elevation of the Subject Building was 2 feet, 2 inches NGVD 1929 (or 2.17 ft). To convert between different datums or reference frames, the National Geodetic Survey Coordinate Conversion and Transformation Tool (NCAT) is used (https://www.ngs.noaa.gov/cgi-bin/VERTCON/vert_con.pl). The difference between the two vertical datums at the subject building in Surfside is 1.555 feet. Therefore, the floor of the garage is at $2.1677 - 1.555 = 0.61$ feet. The garage floor is an 8-inch-thick concrete slab, meaning the bottom of the slab is at elevation -0.06 NAVD 88. The slab rested on the pile caps. Figures 8 to 10 present the columns in the building, garage floor column plan and pile cap locations respectively. The reinforced concrete pilings appear to be 24" in diameter. Figure 11 shows that the pile caps are 3'-6" to 4'-0" thick, meaning they are all below -0.6 ft NAVD 88.

Figure 7. Elevation of the Champlain Towers South building indicating the garage floor at elevation 2'-2". Source: Freidman (Town of Surfside, Public Records. 1979.) Sheet 8 of 30.

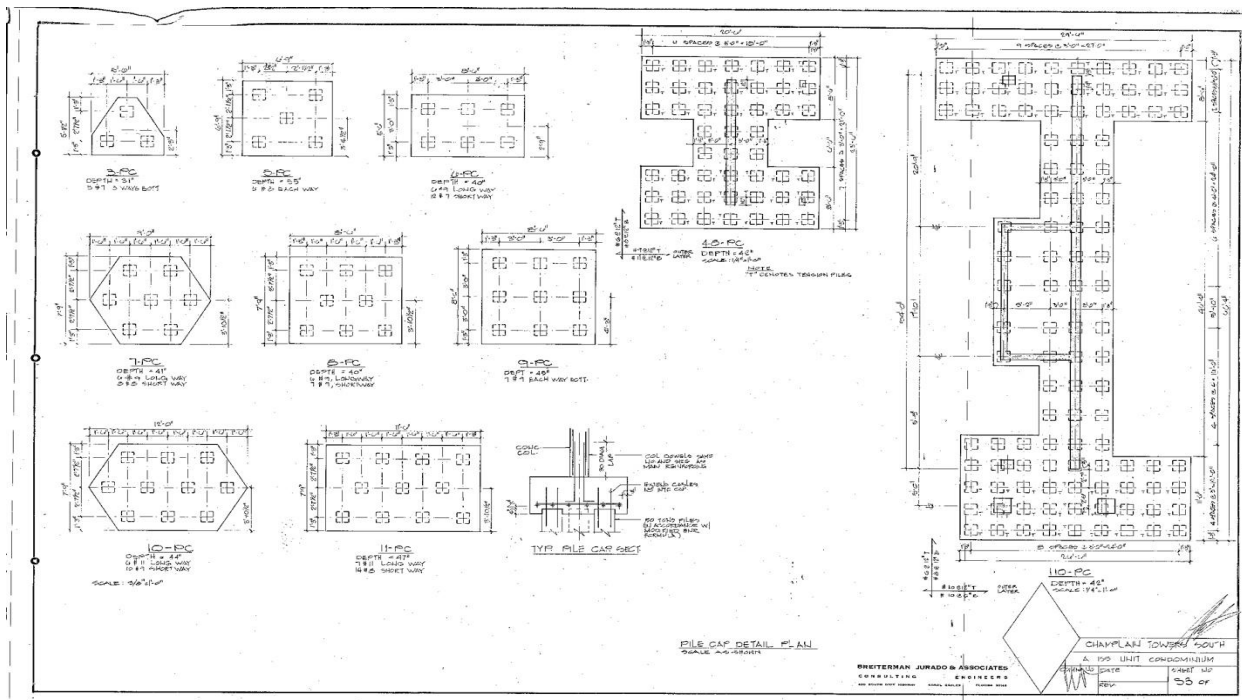
Figure 11. Pile cap details. Note that pile caps are located below the garage floor. Source: Brierterman, Jurado & Friedman (Town of Surfside, Public Records. 1979.) Sheet S3.

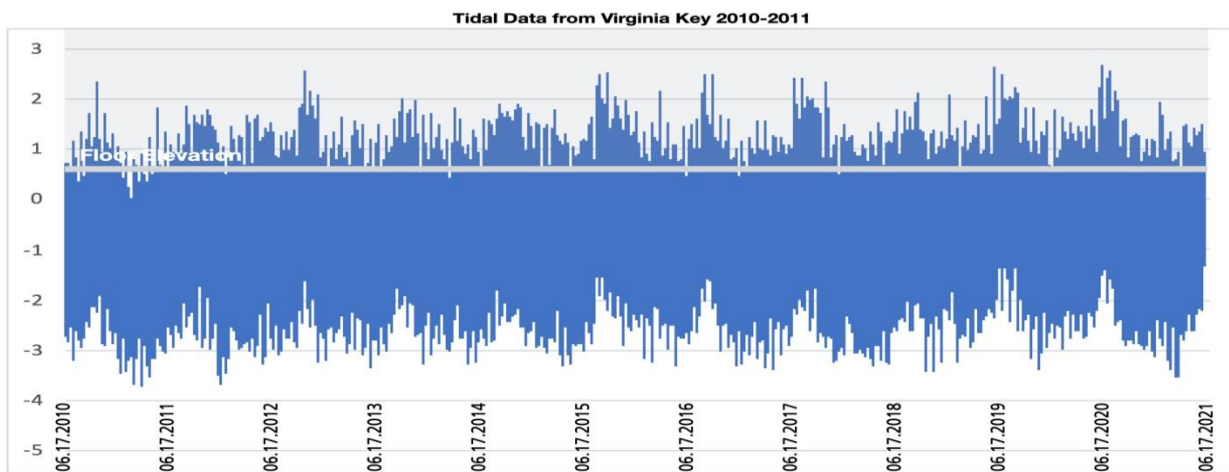
The fluctuation of high and low tides is a twice daily occurrence in South Florida. The elevation of high tides is influenced by the combined gravitational forces of the earth, moon and sun. The highest tide levels occur twice annually when these bodies are aligned at perigeon and perihelion. The annual and daily tidal cycles are shown in Figure 12 for the Virginia Key NOAA site, while Figure 13 shows the Virginia Key (“VK”) site in addition to the two

Figure 12. Tidal Data from Virginia Key 2010 to 2021. Note the level of the garage floor at Champlain Towers South. Graphic: Abbate and Bloetscher (2022)

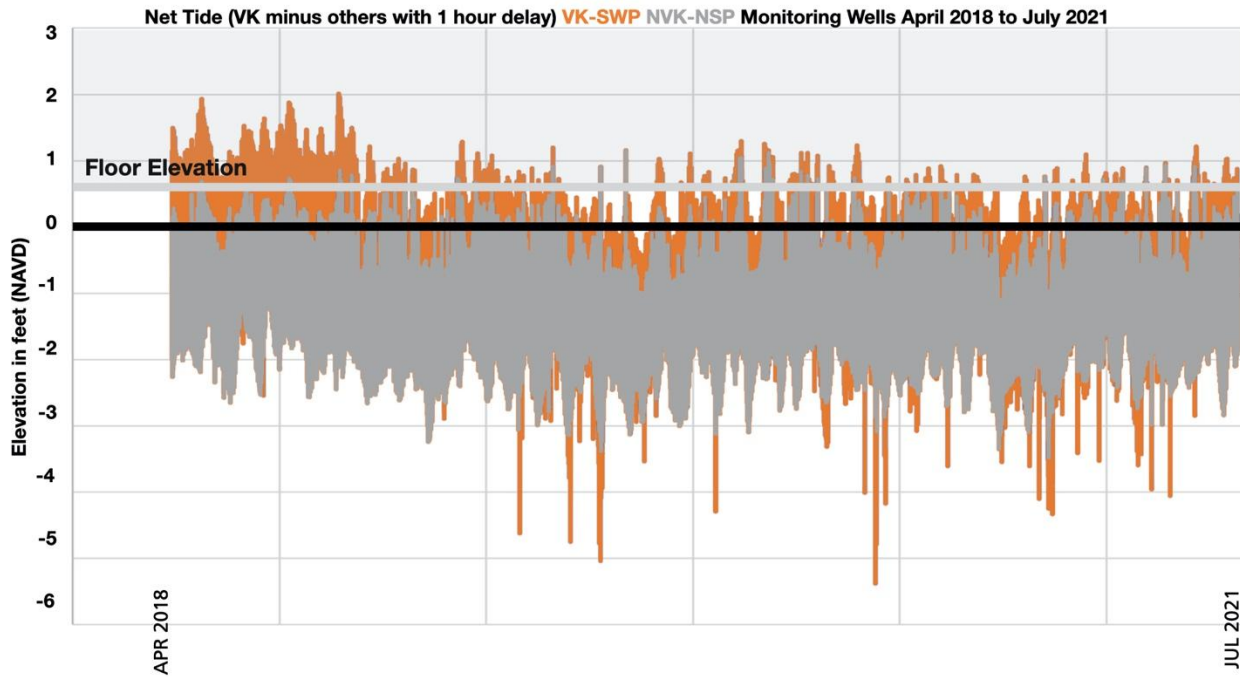
Based on an analysis of the groundwater at the two wells on the island, versus the tides (accounting for a 1-hour delay for groundwater movement), the SWP site appears to be a few inches higher than the VK site for most of the time and presented less so for the NSP site. Figure 14 indicates the difference between the two sites mapped chronologically. This data indicates that while freshwater may present above the saline water much of the time, there are many periods when the tides are higher than the measured groundwater levels, indicating the absence of appreciable freshwater at the sites. The presence or absence of a freshwater lens is justified by the Ghyben-Herzberg principle discussed earlier (see Figure 15).

Figure 14. Difference between VK and the SWP and NSP sites. All recorded measurements presenting above the black line indicate where no freshwater lens likely exists. Graphic: Abbate and Bloetscher (2023)

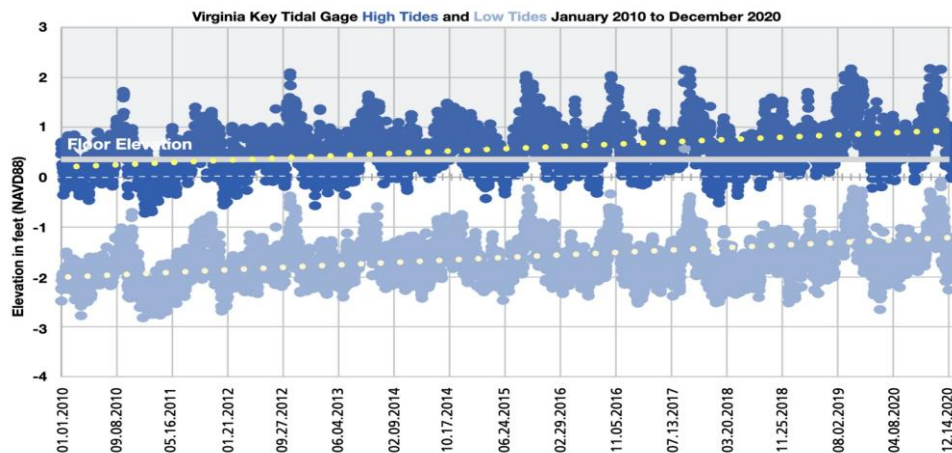
Figure 16 shows the daily tidal trend at Virginia Key. Tides have been increasing over the past 10 years indicating the likelihood of more frequent saltwater saturation at the foundation. The estimated water levels under Champlin Towers present a condition where the wetting and drying, freshwater and saltwater cycles repeated with regularity. Correlating the tidal and garage floor elevations (see Figure 17: the red dashed line marks the garage floor elevation), suggests the foundations were likely to have been constantly exposed to saltwater (Figure 17). This would indicate that periodic and regular exposure to saltwater occurs to the foundation systems, precisely the condition that accelerates deterioration of the steel reinforcement.

Figure 16. Trend of high and low tides recorded from the VK tidal gage. Floor elevation indicates the level of the garage floor at Champlain Towers South. Graphic: Abbate and Bloetscher (2023)

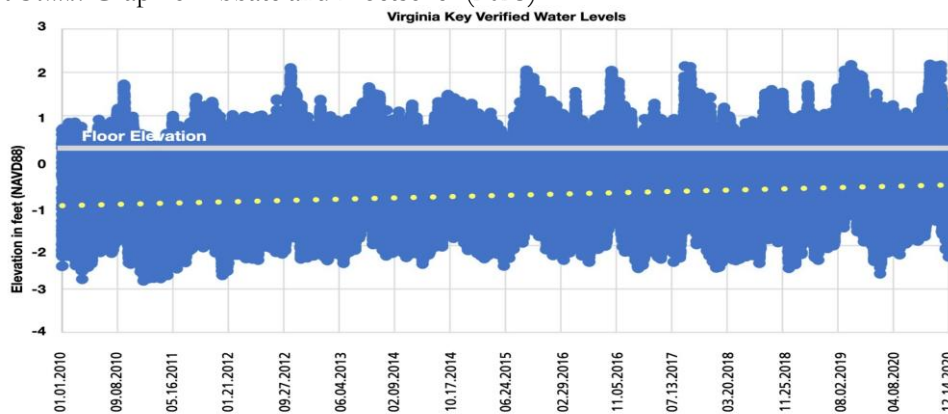
Figure 17. Estimated water levels under Champlain Towers over a 10 year period, indicating a condition where the wet/dry and fresh/salt cycle repeated with regularity (including “King Tide periods” where the foundations were continuously exposed to saltwater). Graphic: Abbate and Bloetscher (2023)

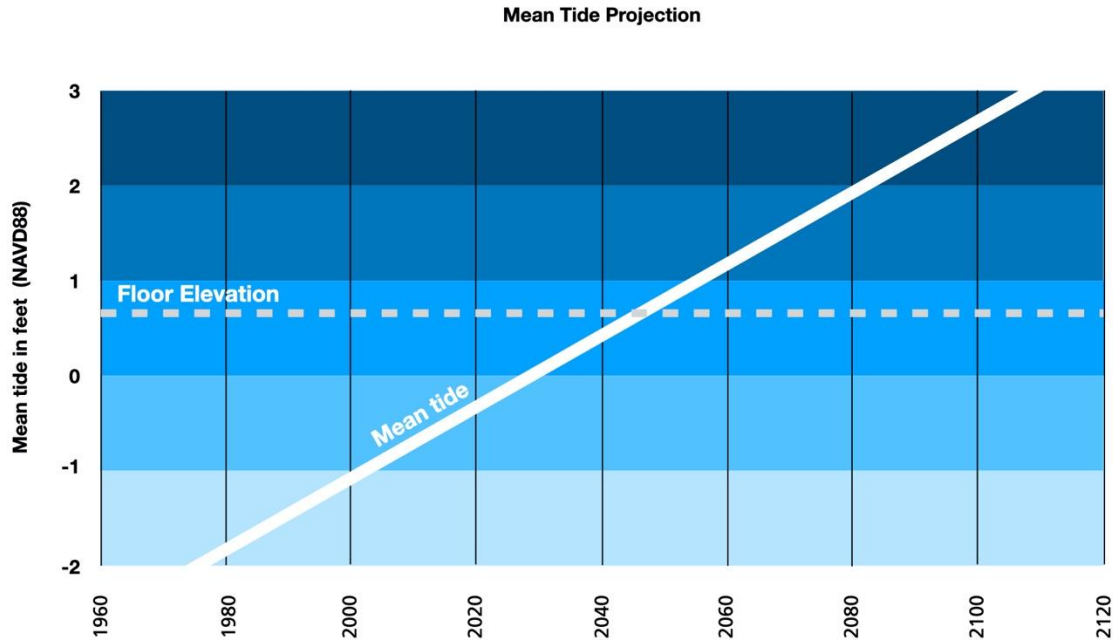
Having determined that periodic exposure exists, and is increasing with time, Figure 18 shows a projection of the water levels back to 1979 when the project was designed. Note that the tide was 5 inches lower than the 2021 condition. A more infrequent salt-water exposure may have occurred during that time with the pile caps remaining above the groundwater levels. Also, given the assumption that the tidal levels were within a constant and predictable range and not subject to sea level rise at the time, there would have been little expectation that the pile caps were going to be exposed to saltwater. Going forward, projecting sea level with a linear increase indicates that by 2046 the top of the floor will be at the tide level for 50% of the time.

Figure 18. Projection of mean tides from 1980 to 2100 showing that the mean tide will be above the garage floor by 2045. (Using a linear projection: $\text{Mean Tide} = 0.038773 * \text{year} - 78.715$) Graphic: Abbate and Bloetscher (2023)
