Journal of Engineering and Architecture June 2015, Vol. 3, No. 1, pp. 109-115 ISSN: 2334-2986 (Print), 2334-2994 (Online) Copyright © The Author(s). All Rights Reserved. Published by American Research Institute for Policy Development DOI: 10.15640/jea.v3n1a11 URL: http://dx.doi.org/10.15640/jea.v3n1a11

The Restoration of a XVIIth Century Roman Noble Residence

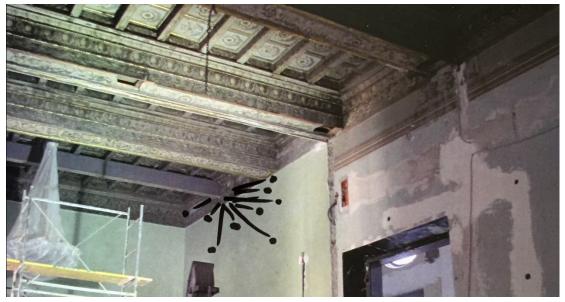
Fig. 1: Wooden ceiling. Clearly Visible, on the Left There is a Steel Beam.

Steel beam to help holding the loads supported by damaged secondary wooden structure (Fig.1). The idea of the actual owners was to restore the palace removing the ill-handling of the first half of XXth century made by their ancestor in a period of serious monetary misfortune. In need of money and wanting to rent all the room he had, the last prince handled the property with such violence that big ballrooms were divided and made whole little apartments to let.

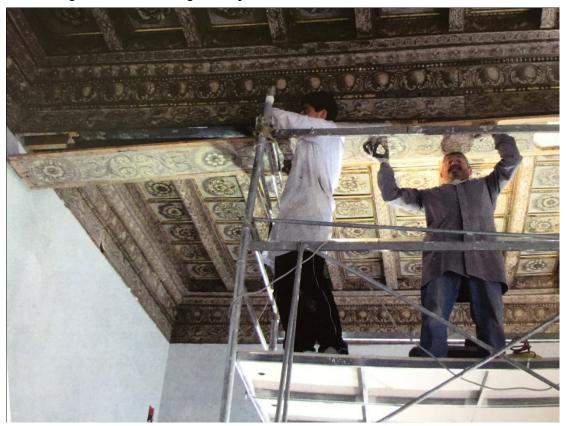
Fig. 2: Removing he Decorated Planks from the Main Wooden Beam

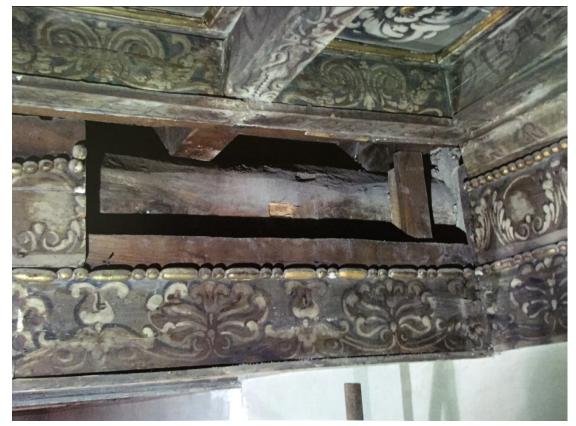
Fig. 3: Detail of the Ceiling. The Structure Made by Wooden Beams was Enclosed in a Series of Decorated Planks

The structure of the ceiling is made by primary large wooden beams of about 50 by 50 cm and by secondary smaller beams of about 18 by 18 cm. While the primary beams are raw and enclosed in a decorated wooden skin, the smaller beams are axe-squared, solid and decorated on their three outer surfaces. As was mentioned before, the richly decorated wooden ceiling was maimed by the use of a steel beam. All the decorations have been damaged both by the smoke of a fire that was set by accident some decades ago and by the water used to extinguish it. The first step was to remove, classify and number all the wooden decorated planks (Fig.2). After the study of the kind of paint and medium that was used to apply it when it was originally done, we begun a massive and careful work of restoration eliminating the smoke and water stains but maintaining the time patina. It is no use to bring a four hundred decoration to its 'as new' condition. Removing the wooden planks, the original wooden beams were revealed (Fig.3). These bore the signs of a series of restorations, mainly steel hoops, set to reinforce the splintered wooden beams. The footings of the beams were also very liable. To reinforce the footings we used a series of supports to hold the beams in their places and reinforced the masonry at their heads by using the same kind of bricks and mortar (Fig.4). It is very important to use the same materials that have been used for the original wall to ensure the continuity of the stress lines that flow through the masonry. The next step was to remove the steel beam that supported a whole set of secondary decorated wooden beams. Unfortunatly these were irremediably damaged. This time, the cause of their degrading was the passing of time and the work of the moths. How to intervene in this case? As the secondary wooden beams were not able to support the load, removing the steel beam would have made the structure to collapse; furthermore they were so damaged by moths that in a simple matter of time they would lose any static value.

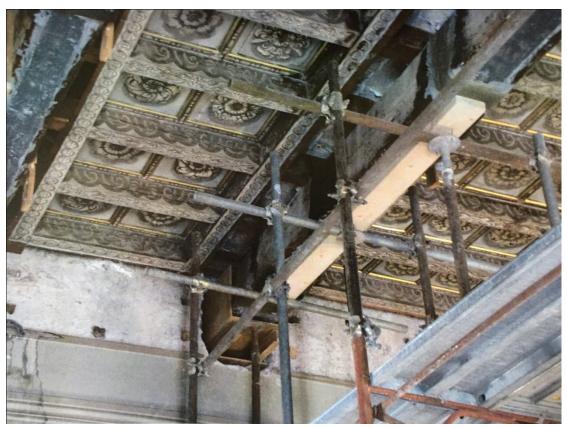
Fig. 4: Reinforcing the Beam Supports

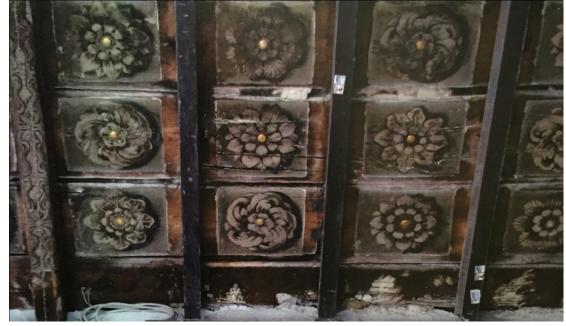
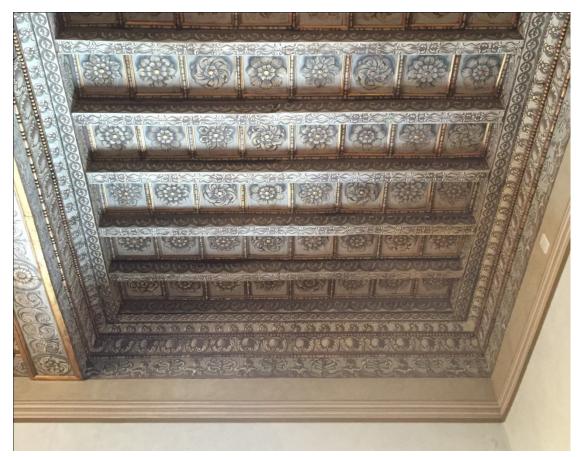
Fig. 5-6: Top. The Irremediably Damaged Secondary Wooden Beams are Replaced with Steel Ones, the Next Step (Bottom) Is to Use the Same Technique Used in Ancient Times for the Primary Beams that Were Covered by Applying Decorated Planks

For this task, we decided to imitate the decorations of the main beams As these were plated by wooden painted planks, we decided to cut off the skin of the old wooden secondary beams, and using it to plank the steel beams that would replace them (Figg.5-6). The decorated wooden ceiling was thus restored to its original beam weaving.
