## Anatolian Rural Adobe Architectural Heritage: Case of Seyitüŝađı Rural Settlement

Tuba Nur Olđun<sup>1\*</sup>, Müjgan Bahtiyar Karatosun<sup>2</sup>

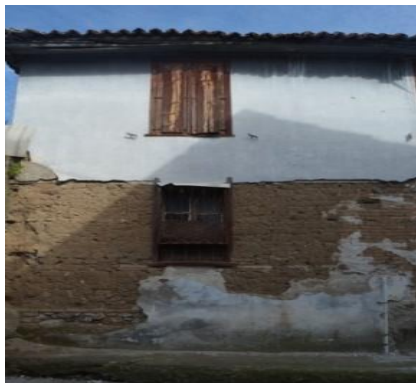
Figure 1. An adobe building in Havran

In many parts of the world, as well as in urban and rural areas of adobe material is used in Turkey, where there are residential buildings of adobe has several functions. However, economic activities in rural areas are intertwined with nature; therefore, the functional properties of structures are greatly affected by natural data and traditional factors are at the forefront; however, it is possible to say that the density of adobe buildings is higher than urban areas due to reasons such as less use of technological data. Thus adobe building production, especially in rural areas located in Turkey is widespread in Anatolia (Figure 1, 2).

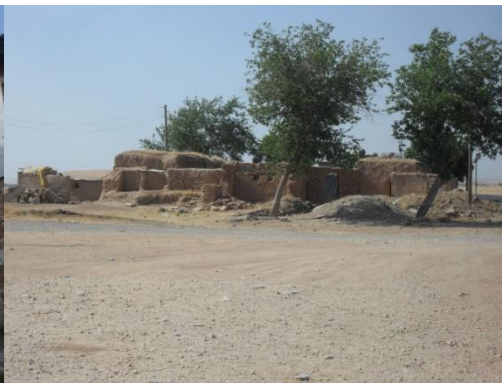
Figure 2. An adobe building in Suruç

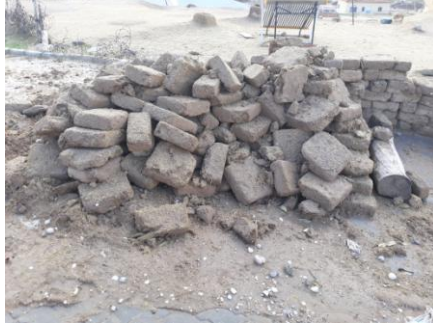
Figure 3. Adobe blocks

- Massive adobe construction system (with adobe blocks, forged adobe or masonry adobe)
  - Light adobe construction system (with adobe block filling or cast adobe filling). (Çelebi, 2012). (Figure 3, 4).

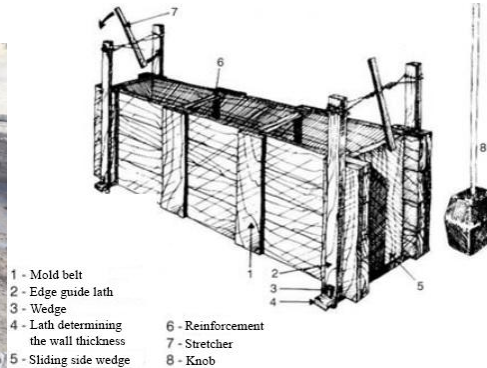
Figure 4. In cast and masonry adobe systems used wall formwork and mold forming elements (Acun and Gürdal, 2003)

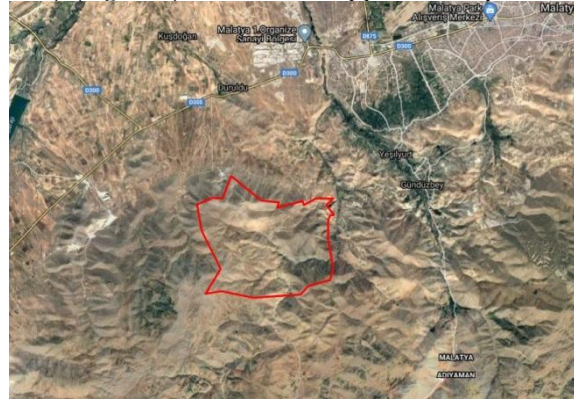
Figure 6. Günpınar rural settlement borders and its immediate surroundings (Parselsorgu, 2020)

Seyituşağı settlement is located on a hilly terrain. The settlement covers an area of approximately 13.40 km<sup>2</sup> with agricultural lands (Parselsorgu, 2020) (Figure 6). It is located approximately 32 km from the city center.

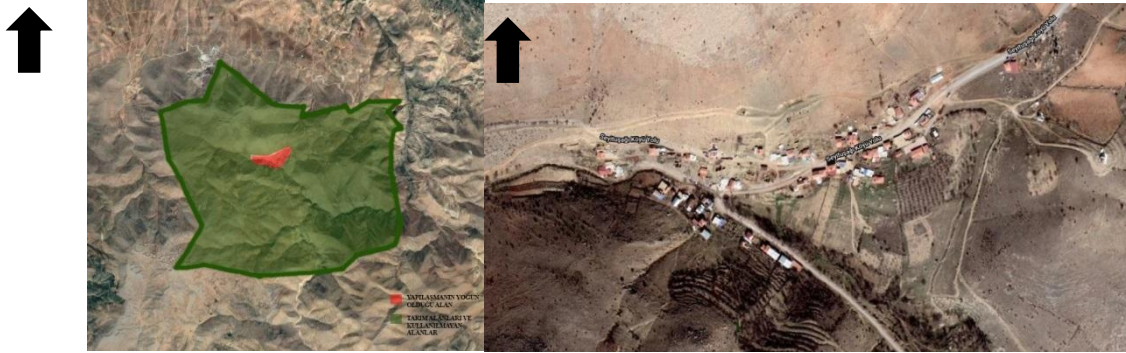
Figure 8. Areas of dense construction and agricultural areas in Seyituşağı (edited from Parselsorgu, 2020)

The area where the settlement is concentrated in Seyituşağı is located in the north considering the whole area of the settlement. There are scattered agricultural areas in areas close to and far from the built environment. Regions outside these areas are not used in any way. (Figures 8, 9).

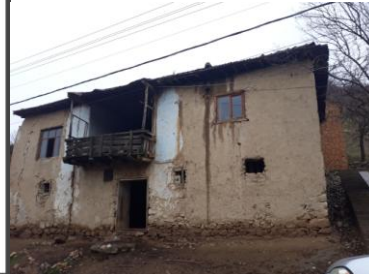
Figure 20. A two storey house in Seyitüşağı

Looking at the number of floors of the buildings in the rural settlement of Seyituşağı, it is seen that there are no more than 2 floors of buildings. However, it has been observed that single-storey buildings make up approximately %88 of the total building stock. In this context, it is possible to state that single storey buildings are more than two storey buildings throughout the settlement (Figure 19, 20).

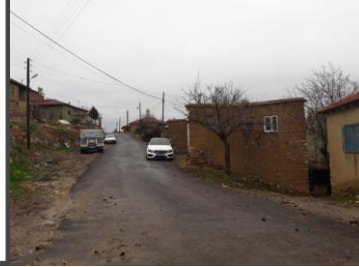
Figure 24. A vehicle+ pedestrian road in Seyituşagi

both ways. However, it can be stated that roads consisting of only soil material are also common with the use of soil on both sides of asphalt and asphalt in street pavements. (Figure 23, 24, 25, 26).

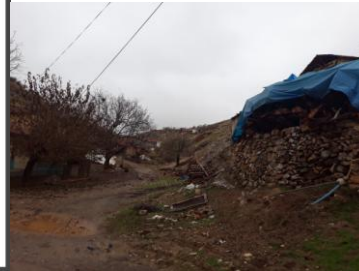
Figure 26. A street with soil material in Seyituşagi

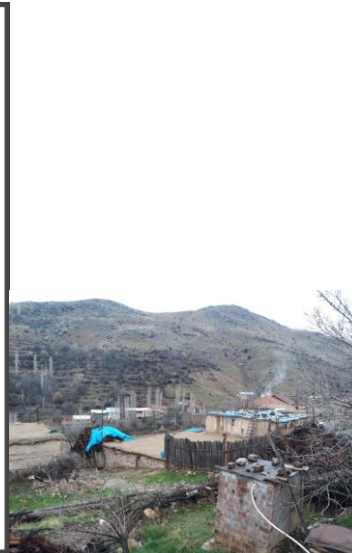
Figure 28. A flat roof in Seyituşağı

When looking at the top cover material and type of the buildings in the settlement, adobe and Marseille type tiles draw the attention. However, a small number of Turkish style tiles, metal sheet and plastic material top covers are also seen. Top cover types are mostly flat and hipped roofs; in addition to these, it consists of gable roofs. As a result of oral interviews and investigations in the field, it was learned that Turkish style tiles were used in many buildings before Marseille type tile materials. (Figure 27, 28, 29, 30).

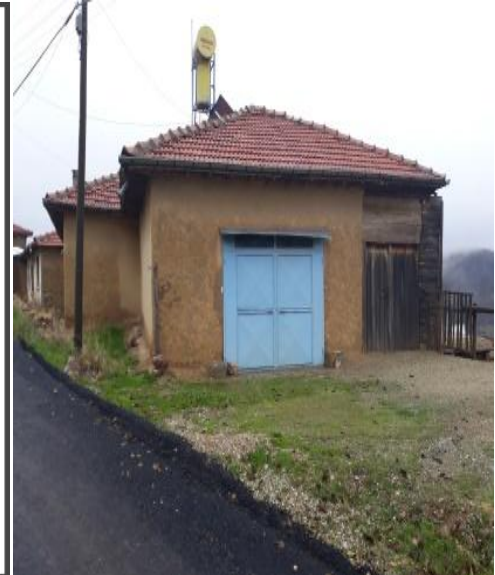
Figure 30. A roof with Marseille type tile in Seyituşağı

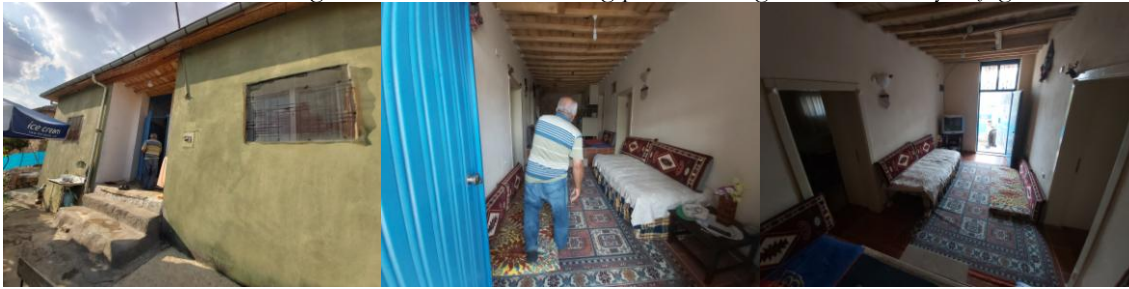
Figure 32. A one storey house's enter facade and hall/saloon place

In all schemes, the hall space, where the main entrance of the building is provided, is also used for functions such as sitting, sleeping, entertaining guests, and eating. (Figure 31, 32).
