Can Sea Level Rise and Accompanying Saltwater Intrusion Contribute to Catastrophic Building Failures?

Frederick Bloetscher¹, Ph.D., P.E.; Anthony Abbate¹, N.C.A.R.B., A.I.A.; and
Khaled Sobhan¹, Ph.D., E.I.

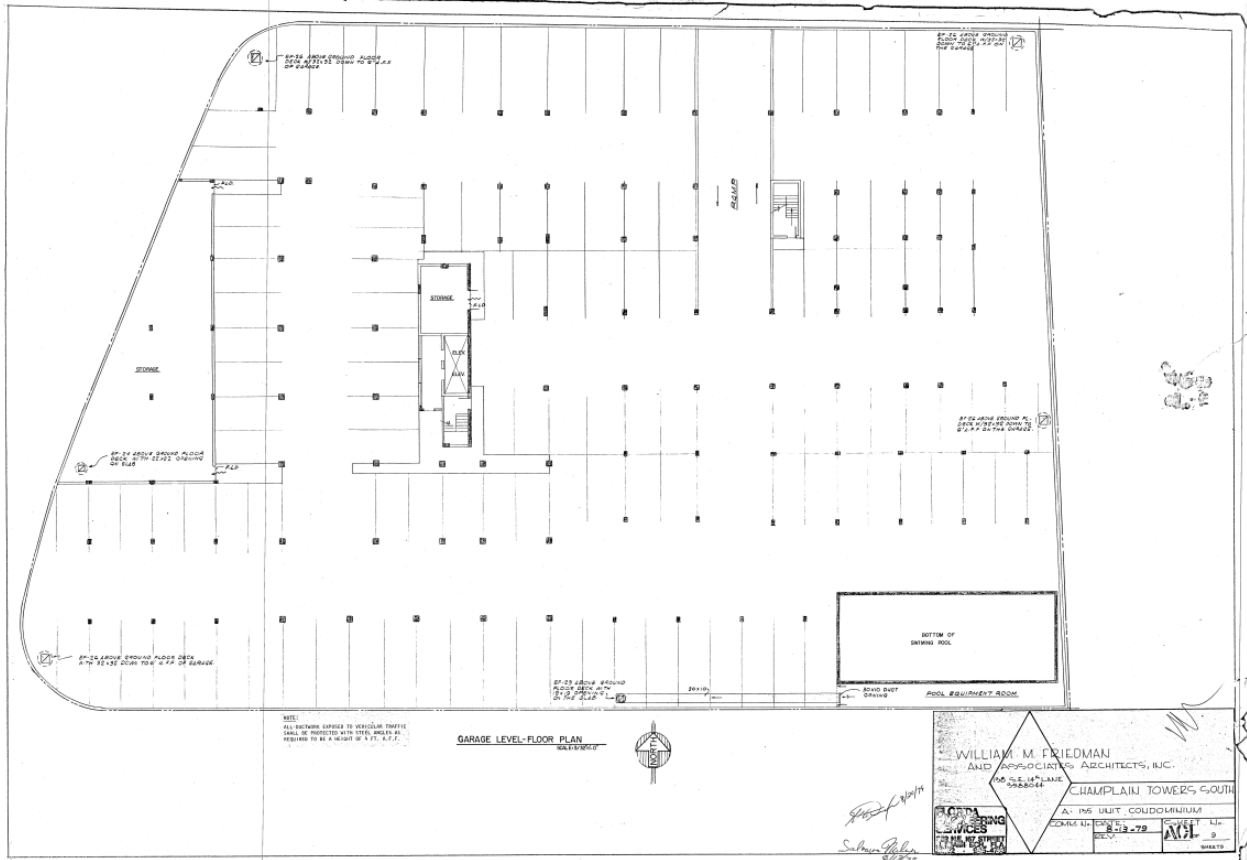
Figure 8. Location of the columns and walls at the garage level in the Champlain Towers South building. Source: Freidman (Town of Surfside, Public Records. 1979.) Sheet AC1 of 9

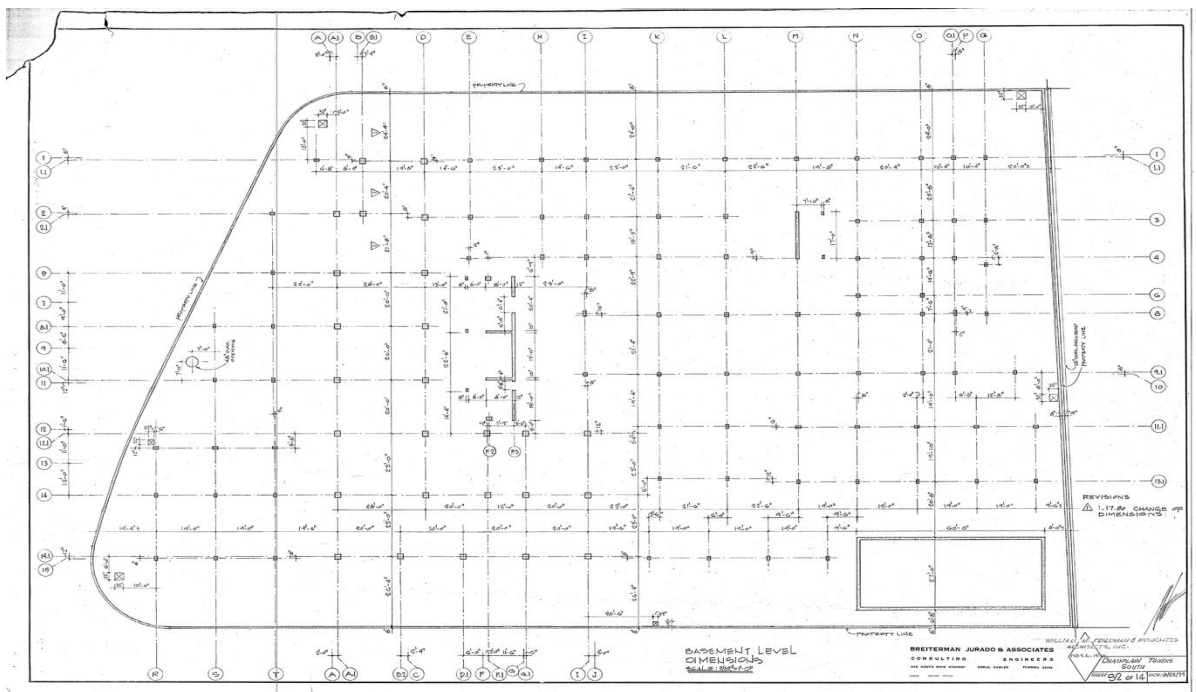
Figure 9. Location of the structural columns and walls at the garage level in the Champlain Towers South building. Source: Brieterman, Jurado & Friedman (Town of Surfside, Public Records. 1979.) Sheet S2 of 14.

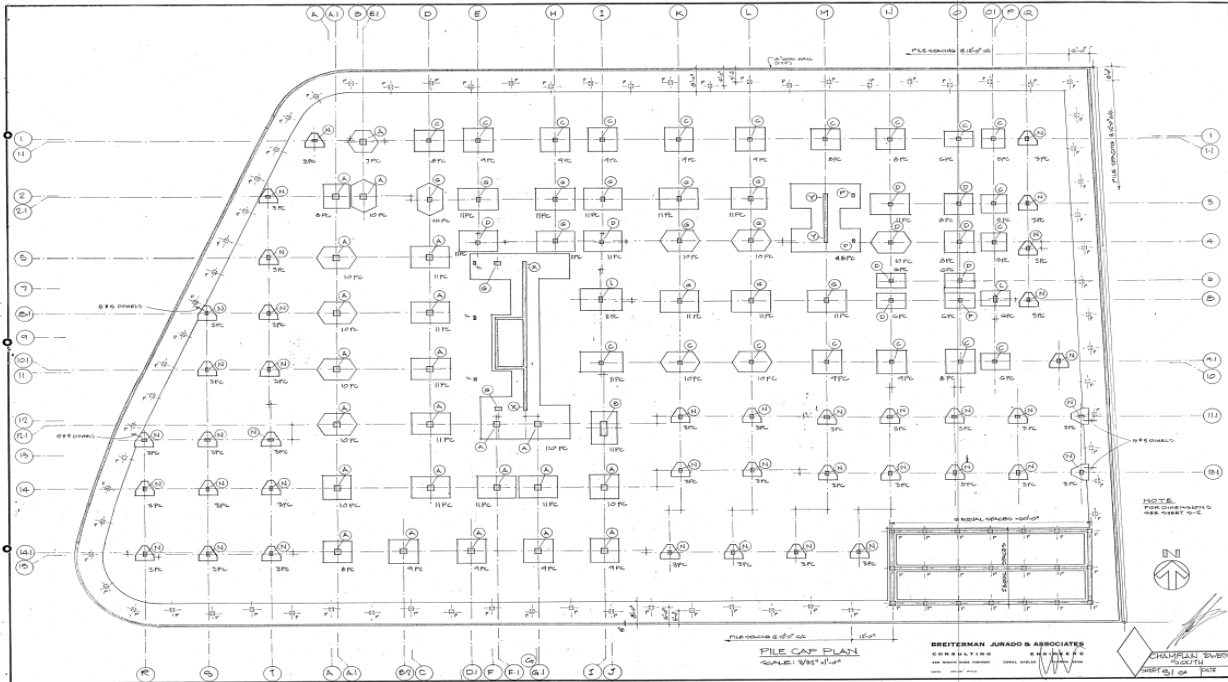
The architectural and engineering plans for Champlain Towers South were acquired and reviewed to determine the design elevations of the garage floor and foundation. Figure 7 shows the elevation of the Subject Building. The finished floor elevation of the Subject Building was 2 feet, 2 inches NGVD 1929 (or 2.17 ft). To convert between different datums or reference frames, the National Geodetic Survey Coordinate Conversion and Transformation Tool (NCAT) is used (https://www.ngs.noaa.gov/cgi-bin/VERTCON/vert_con.pl). The difference between the two vertical datums at the subject building in Surfside is 1.555 feet. Therefore, the floor of the garage is at $2.1677 - 1.555 = 0.61$ feet. The garage floor is an 8-inch-thick concrete slab, meaning the bottom of the slab is at elevation -0.06 NAVD 88. The slab rested on the pile caps. Figures 8 to 10 present the columns in the building, garage floor column plan and pile cap locations respectively. The reinforced concrete pilings appear to be 24" in diameter. Figure 11 shows that the pile caps are 3'-6" to 4'-0" thick, meaning they are all below -0.6 ft NAVD 88.

Figure 10. Location of pile caps in the Champlain Towers South building. Source: Brierterman, Jurado & Friedman (Town of Surfside, Public Records. 1979.) Sheet S1.

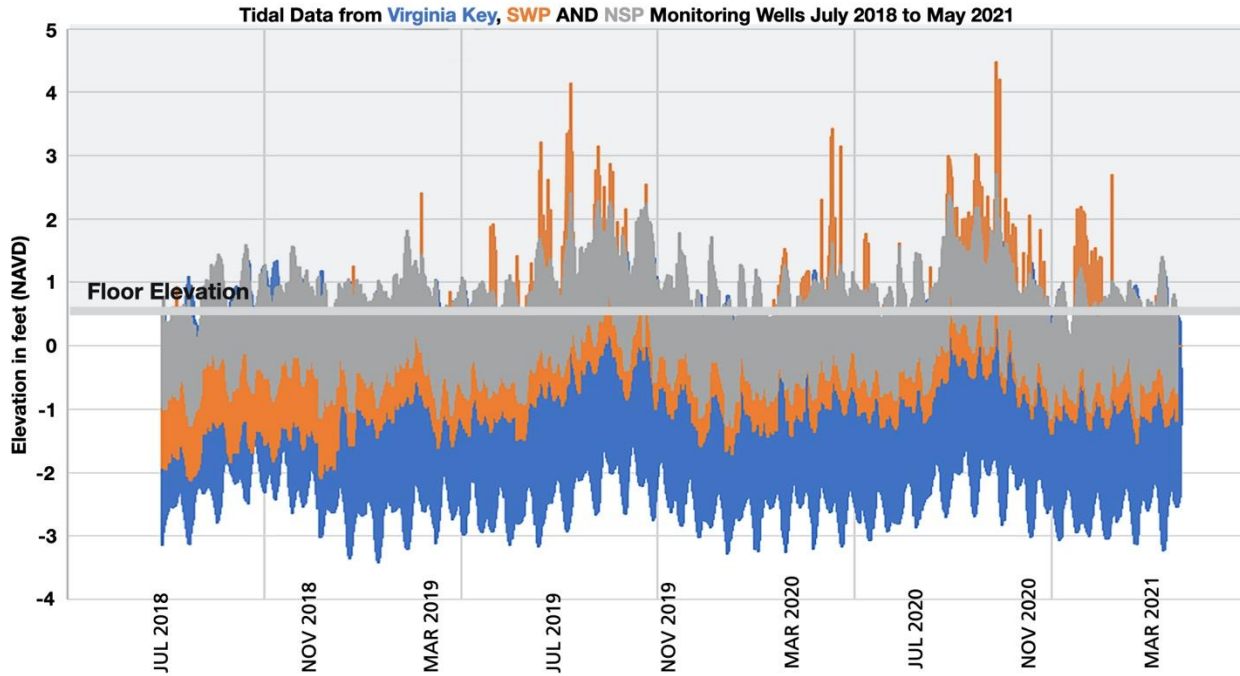
Based on an analysis of the groundwater at the two wells on the island, versus the tides (accounting for a 1-hour delay for groundwater movement), the SWP site appears to be a few inches higher than the VK site for most of the time and presented less so for the NSP site. Figure 14 indicates the difference between the two sites mapped chronologically. This data indicates that while freshwater may present above the saline water much of the time, there are many periods when the tides are higher than the measured groundwater levels, indicating the absence of appreciable freshwater at the sites. The presence or absence of a freshwater lens is justified by the Ghyben-Herzberg principle discussed earlier (see Figure 15).

Figure 13. Virginia Key plus Monitoring Wells SWP and NSP. Note the level of the garage floor at Champlain Towers South. Graphic: Abbate and Bloetscher (2022)

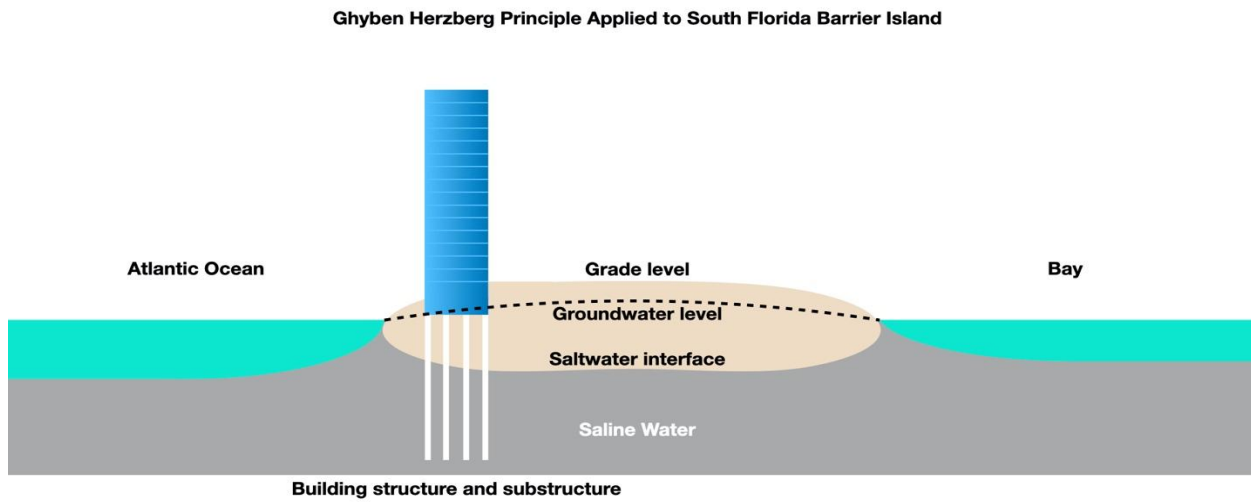
Figure 15. Illustration of the Ghyben Herzberg principle applied to a diagrammatic transect of the barrier island at Surfside, Florida. Graphic: Abbate and Bloetscher (2023)
